METALS HANDBOOK

VOL. 9
FRACTOGRAPHY AND ATLAS OF FRACTOGRAPHY

8th EDITION

Fractography and Atlas of Fractographs

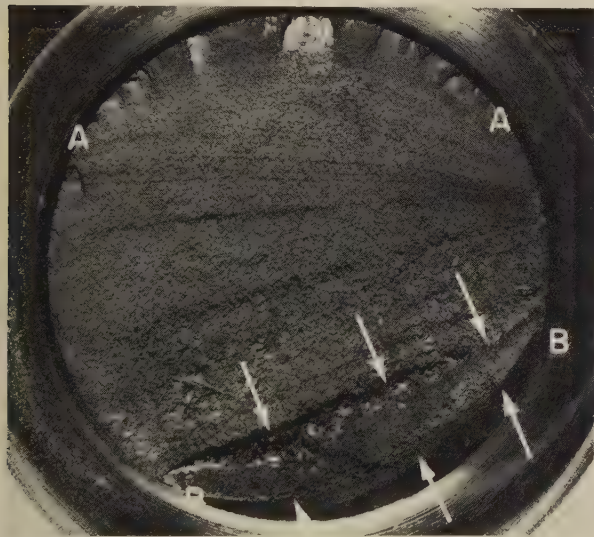
Light fractograph
4796 Surface of a fracture in a lift-truck hydraulic-piston rod of low-carbon steel that broke at a fillet by fatigue. Several fatigue-crack nuclei are evident at top edge (between A's), and there is another at the bottom edge (between B's). Fracture was by reversed bending. Final, fast fracture was in the small region indicated by the arrows. See also 4797.

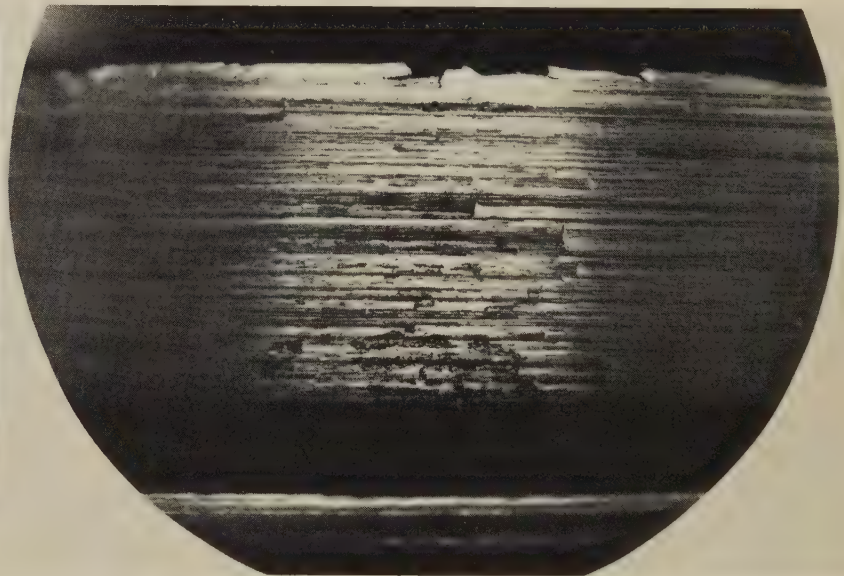
Light macrograph
4797 A view of coarse machining marks that were found in the fillet in 4796 (left) between the larger-diameter portion of the piston rod and the threaded end. A secondary crack that follows a machining mark is visible at top center. These surface marks are considered to be areas of local stress concentrations, which led to fatigue cracking.

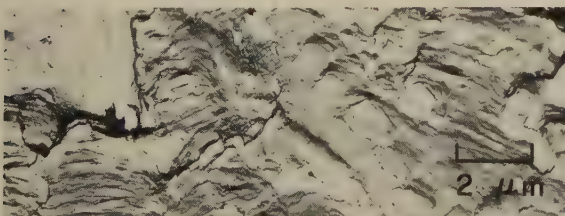
TEM fractograph
4798 Fatigue-fracture surface of a low-carbon steel ship plate broken in a laboratory. Fatigue striations and some signs of dimples.

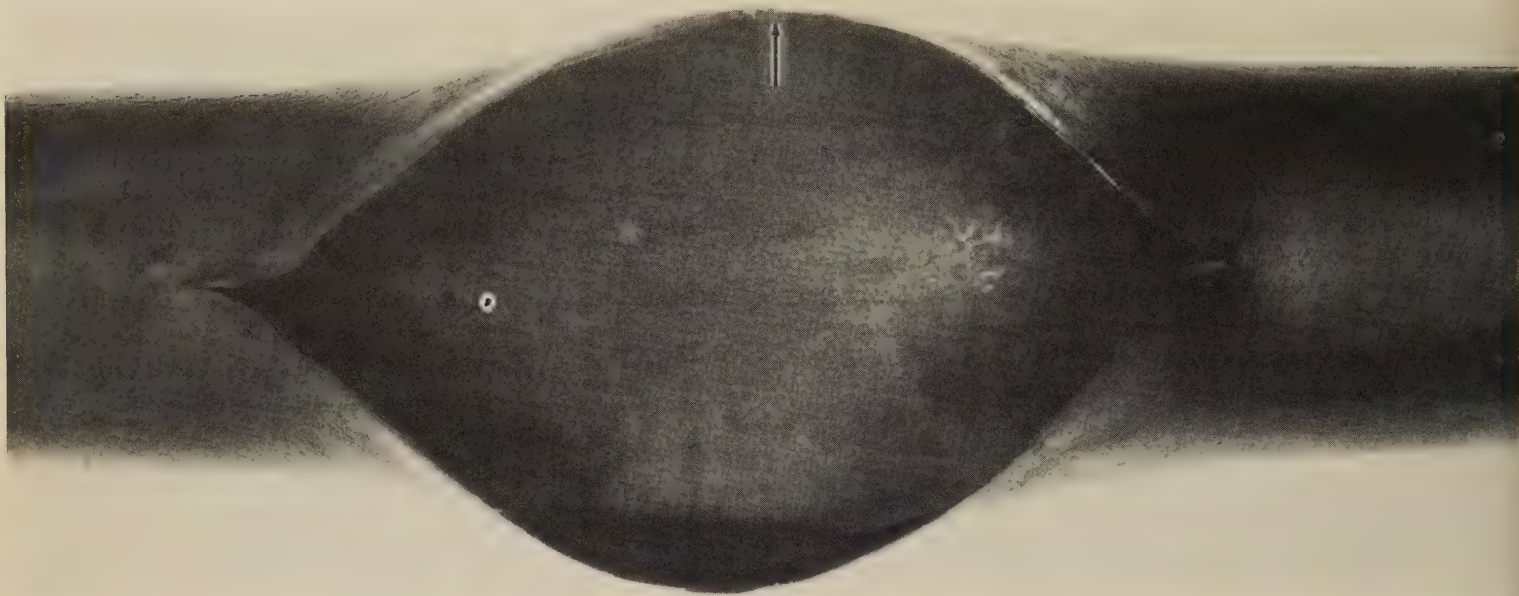
Photograph

4800 Rupture in a low-carbon steel boiler tube with a nominal diameter of 3 in. and a 0.130-in.-thick wall. The rupture produced an opening 8 in. in length and 4 in. in maximum width. A slight bulge, which extended outward about $\frac{3}{32}$ in., was discovered about 2 ft below the rupture. Operating temperature was less than 538 C (1000 F), but local overheating occurred because of steam starvation. See also 4801 through 4804.

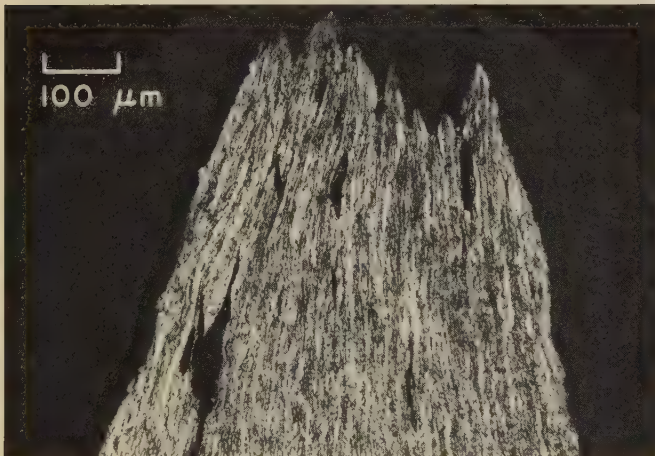
Micrograph (2% nital)

4801 A polished and etched section taken through the highly elongated "knife edge" of the boiler-tube rupture in 4800, showing in profile an area of the rupture surface at the arrow in 4800. See 4802.

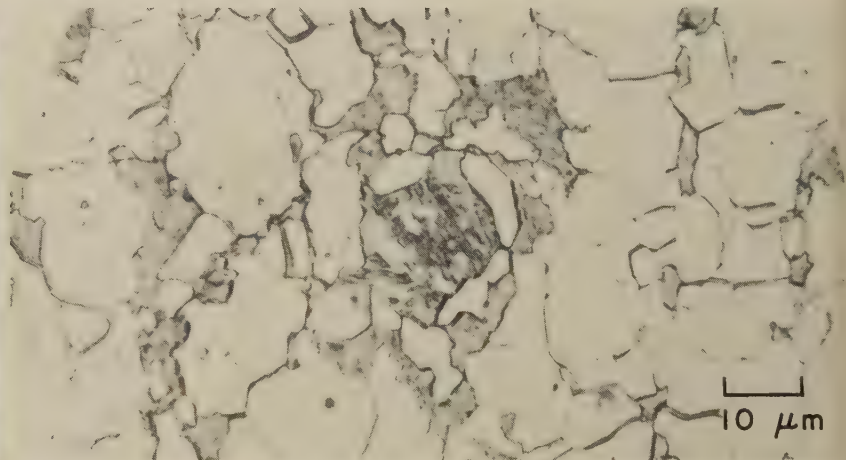
Micrograph (2% nital)

4802 A higher-magnification view of a portion of the section in micrograph 4801, showing ferrite, and low-carbon martensite that was produced at the moment of rupture when steam and water quenched the overheated steel (estimated temperature was 871 C, or 1600 F).

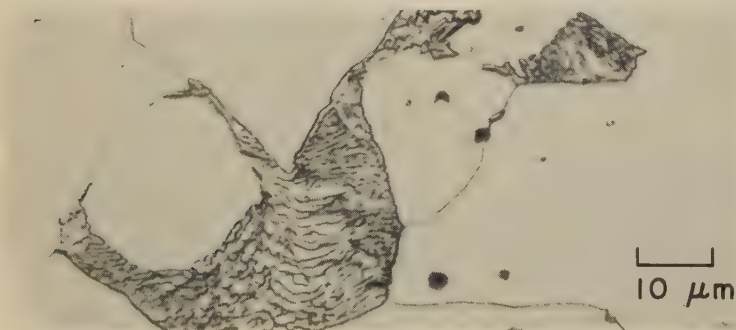
Micrograph (2% nital)

4803 Section through the tube in 4800, taken diametrically opposite the slight bulge 2 ft below the rupture. Microstructure here is normal, indicating that the temperature gradients that caused the bulge and the rupture were local.

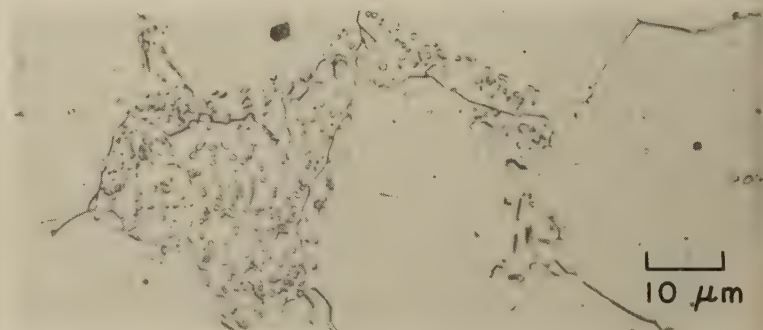
Micrograph (2% nital)

4804 Section through the tube in 4800, taken at the center of the bulge 2 ft below the rupture, showing that the pearlite normally present was altered to spheroidite—presumably because of overheating to between 538 and 677 C (1000 and 1250 F).

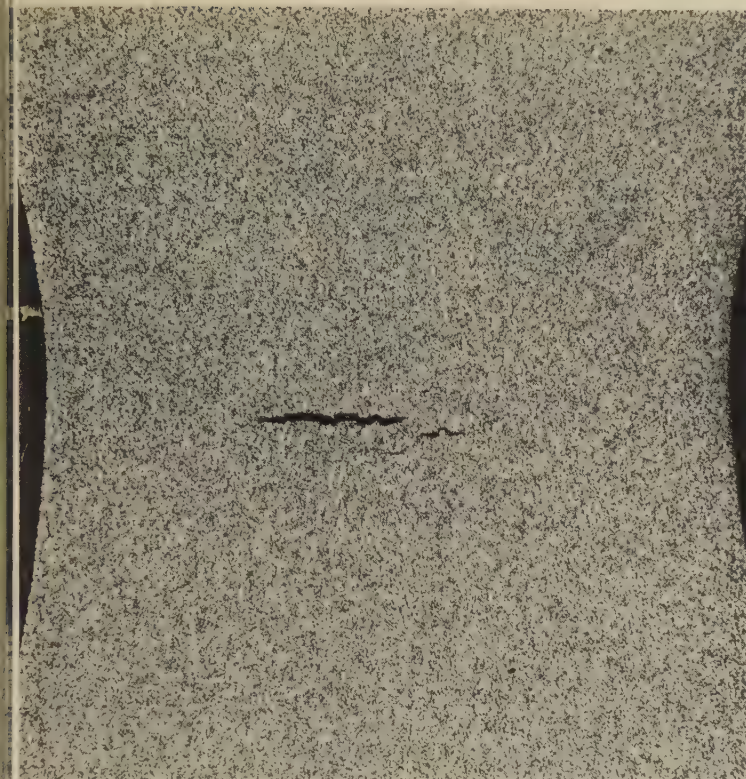
Macrograph (nital)

4805 Polished and etched section taken longitudinally through a 0.505-in.-diam tensile-test specimen of 1020 steel. The tensile test was halted after the centerline cracks shown here were formed but before complete fracture occurred. See also 4806 and 4807.

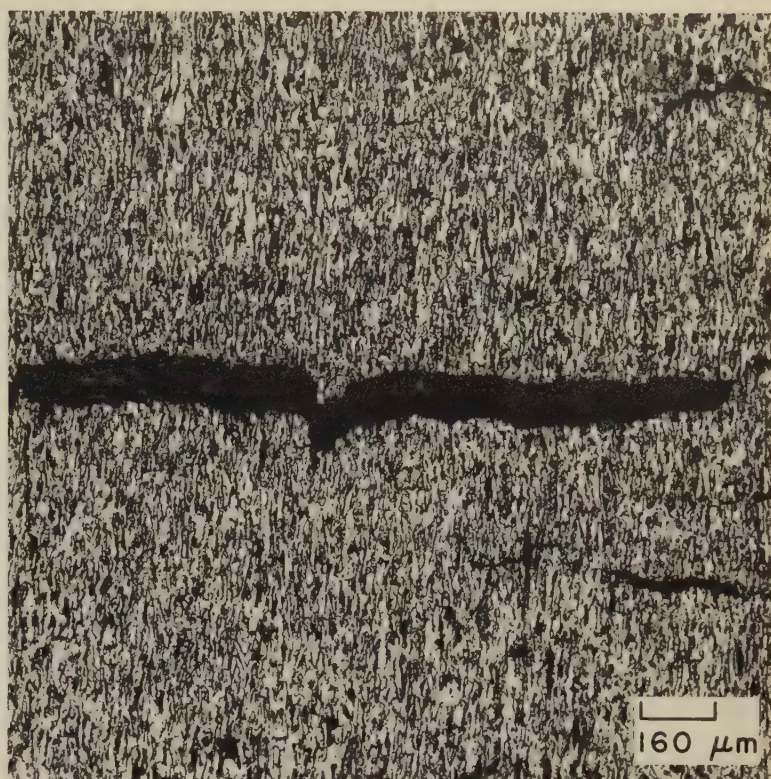
Micrograph (nital)

4806 Higher-magnification view of one of the centerline cracks in the specimen shown in macrograph 4805 (at left), demonstrating that the cracks are transgranular. Secondary cracks also are visible at right, above and below the main crack. See micrograph 4807.

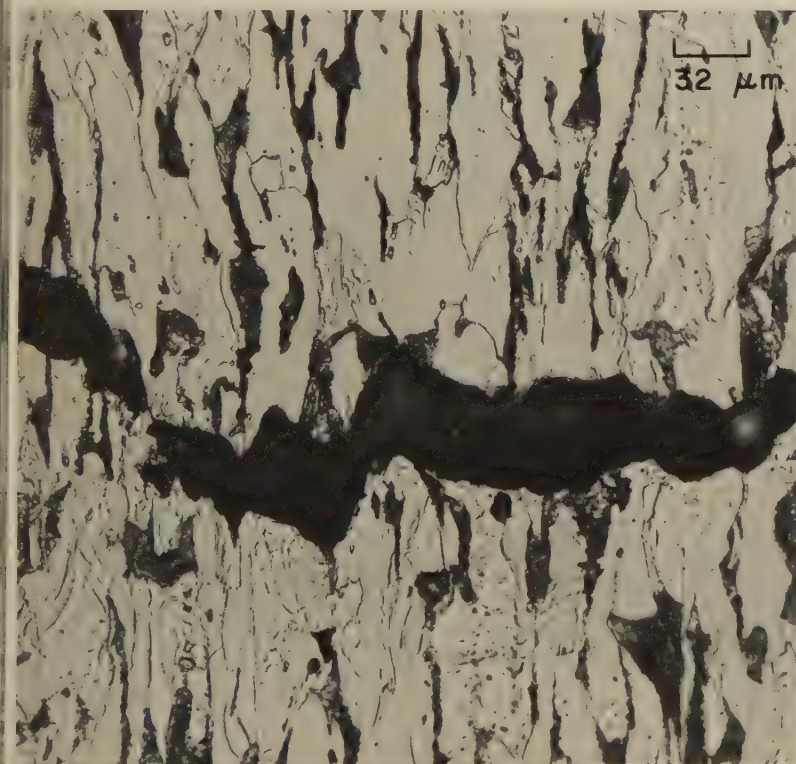
Micrograph (nital)

4807 A further enlargement of a centerline crack in the 1020 steel tensile-test specimen shown in 4805 and 4806 (above). Note that the crack crosses alternate plates of ferrite and pearlite; note also the longitudinal deformation of the original equiaxed structure.

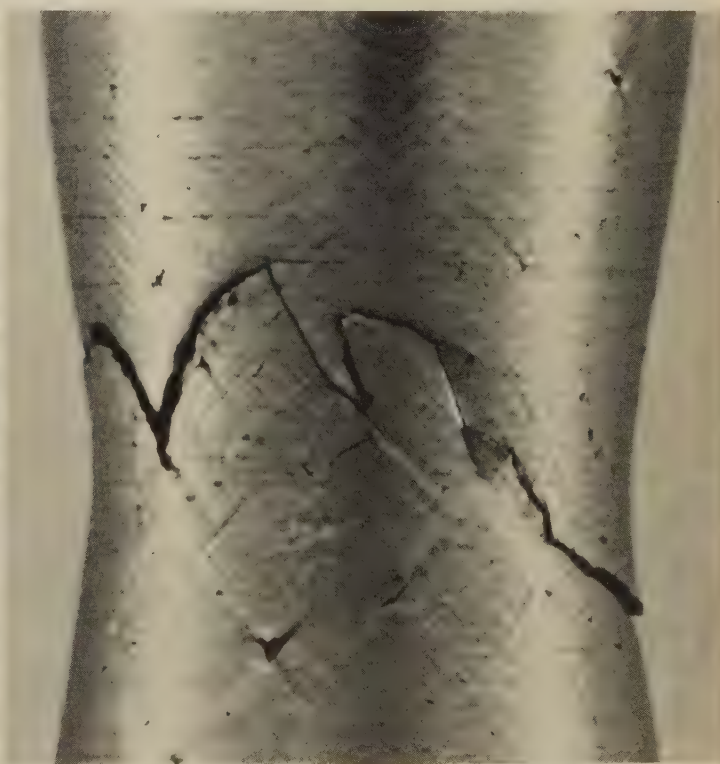
Photograph

4808 Tensile-test fracture in a 0.505-in.-diam specimen of cast 0.20% C steel with hardness of 255 Bhn. Note that pronounced 45° shear deformation has produced shear lips and also numerous secondary cracks, which formed at pores.

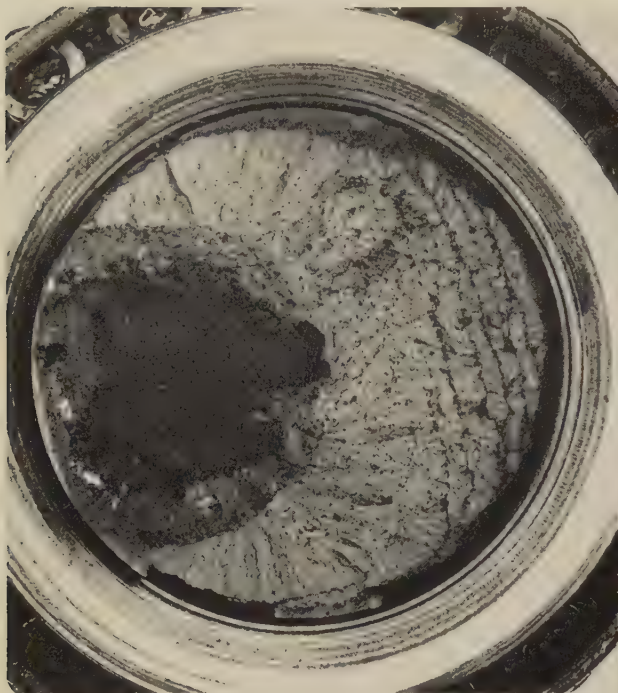
Light fractograph 1.3×
4809 Surface of a fracture in a spindle of cast 0.20% C steel; fracture occurred during a static test. The spindle broke through the large shrinkage cavity visible at left, which exhibits a distinctly dendritic structure. See also fractograph 4810 (at right).

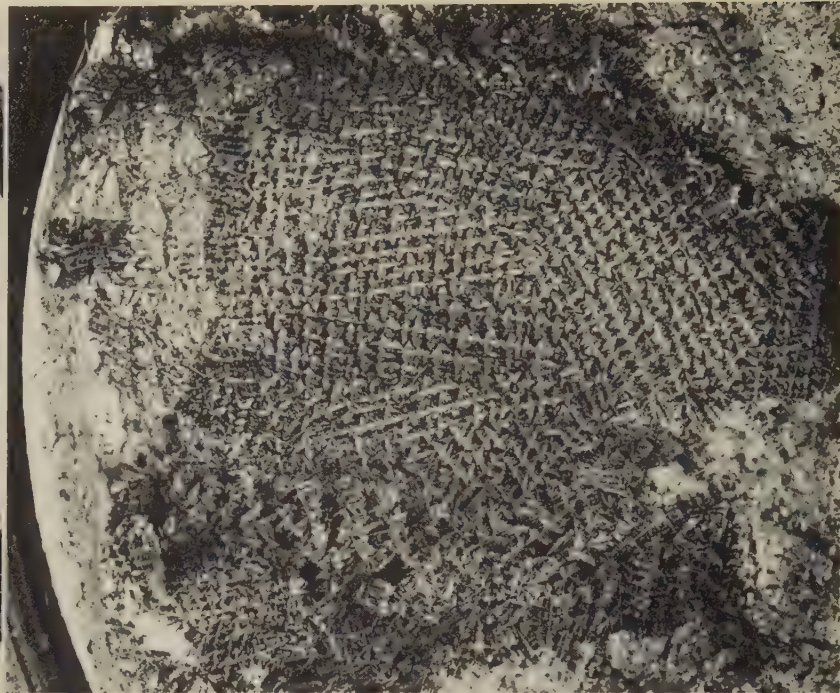
Light fractograph About 4×
4810 Higher-magnification view of the shrinkage cavity in the fracture surface in 4809, showing more clearly the dendritic structure of the cavity. Note the different orientations of the dendrites, as shown by the angles between the various dendritic patterns. Note also the range in size of the dendrites, which indicates different freezing rates.

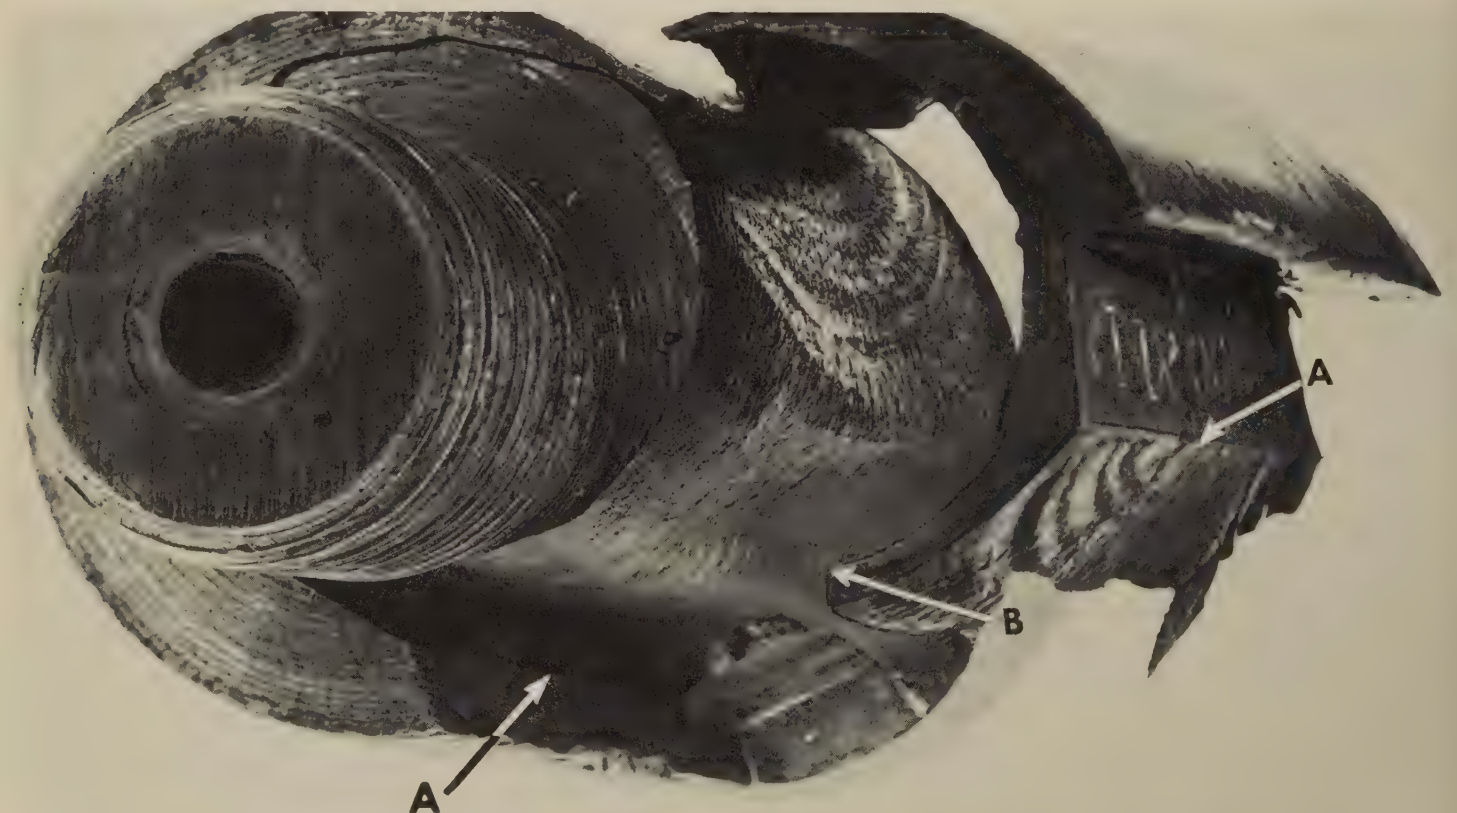
Light fractograph 1.2×
4811 A complicated fatigue fracture in a 3 3/8-in.-diam keyed tapered shaft of 1030 steel, commonly termed a "peeling" type of fracture. A loose nut had reduced the frictional force on the tapered portion of the shaft, transferring the torsional load to the key. The fatigue crack originated at a corner in the keyway (arrows A) and progressed completely around the shaft in a clockwise circular path, returning beneath the keyway to the location marked by arrow B, where final fracture occurred.

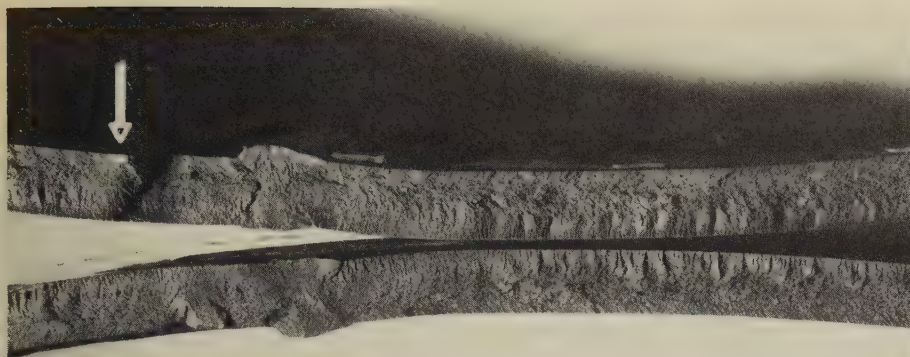
Light fractograph

4812 Mating surfaces of a crack in a shell plate of an ASTM A515, grade 70, steel pressure vessel used in dehydration of natural gas. Normally, operating pressure was 1.5 MPa (220 psi) and operating temperature was -12 to $+4$ C (10 to 40 F). The crack was exposed by sectioning after a leak was discovered. See 4813 to 4817 for views of the portion near arrow at left.

4816 Another view of the fracture surface in 4814, displaying clearly the two dark arc-strike crescents that are indicated in both views by arrows at the top edge of the fracture surface. Chevron marks pointing to these crescents (which are the crack nuclei) are visible both here and in 4812.

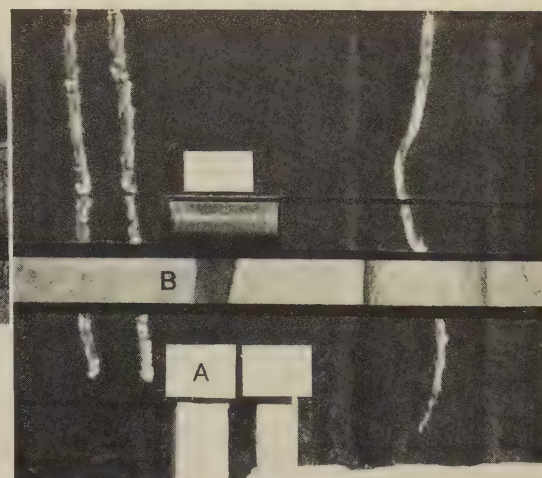
Photograph

4813 Portion of the fractured shell plate in 4812 near arrow. A and B indicate where sections were cut for further study. Fracture surface is shown in profile at bottom.

4815 A polished and etched section taken from location A in 4813, showing the arc strike visible at the left arrow in 4814. The large cracks present here are extensions of the fracture, which is visible in profile at right.

4817 Polished and etched shell-plate section marked B in 4813. Note that the smaller arc strike, visible at the arrow at right in 4814 and 4816, does not extend this far from the fracture. Note also the surface damage caused by the arc strike, in contrast to the excellent condition of the weld deposit.

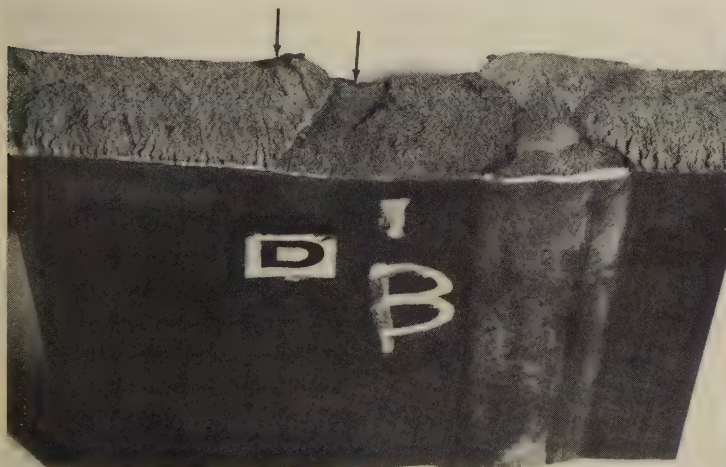
Light fractograph

4814 Same portion of the shell plate as in 4813, but before sectioning and at a different orientation. The two dark crescents partly visible at top edge of the fracture surface (at arrows) were caused by arc strikes and served as crack nuclei.

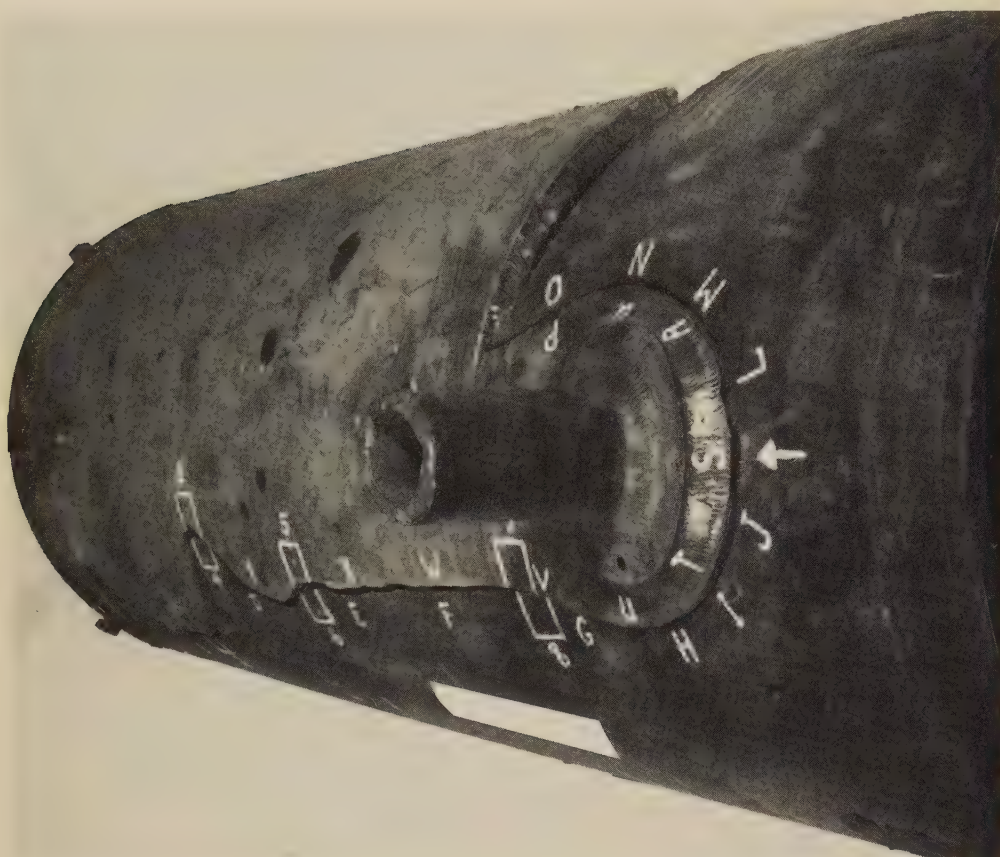
4818 Fractured shell of a 34-in.-diam pressure vessel fabricated from a plate (1¼ by 96 by 360 in.) of ASTM A515, grade 70, steel for pressure vessels. The shell broke during testing at an internal gage pressure of 8.3 MPa (1.2 ksi). The fracture, which originated adjacent to a flange (arrow at S), followed a very complex path. See also 4819 to 4827.

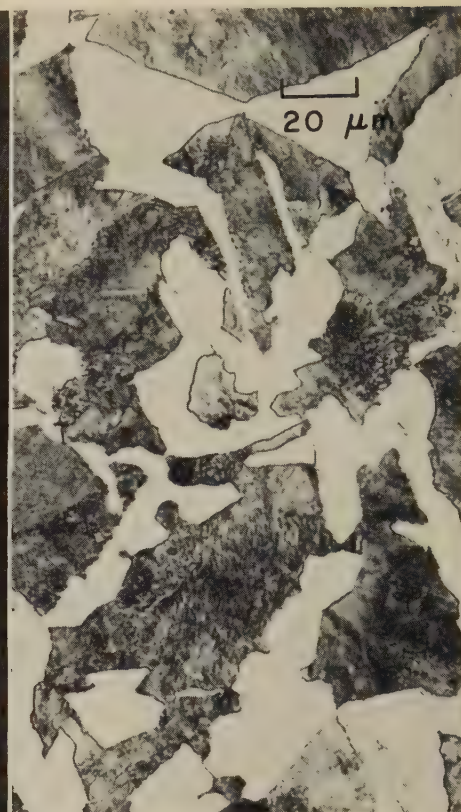
4819 A polished and etched section through the shell in 4818, showing an as-rolled microstructure consisting of a mixture of ferrite and fine pearlite, which resulted in a maximum hardness of Rockwell B 86.

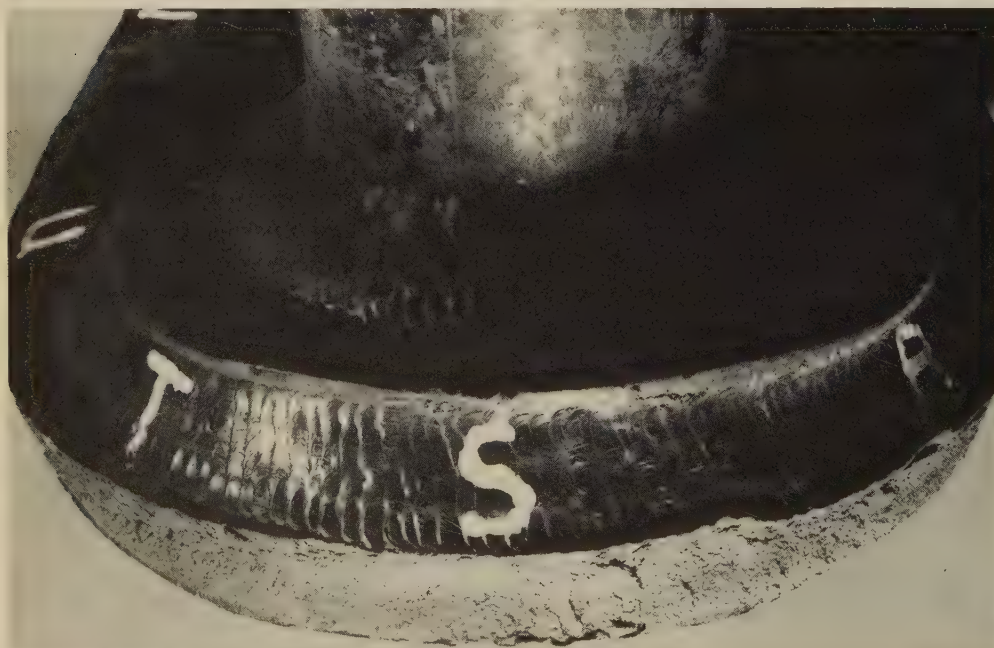
4820 View of the flange in 4818, showing an adjacent area of the fracture surface of the pressure-vessel shell. Although not as discernible here as in 4825 (next page), chevron marks throughout the fracture surface clearly point toward the area at S, and subsequent examination identified the toe of the flange weld at S as the crack nucleus.

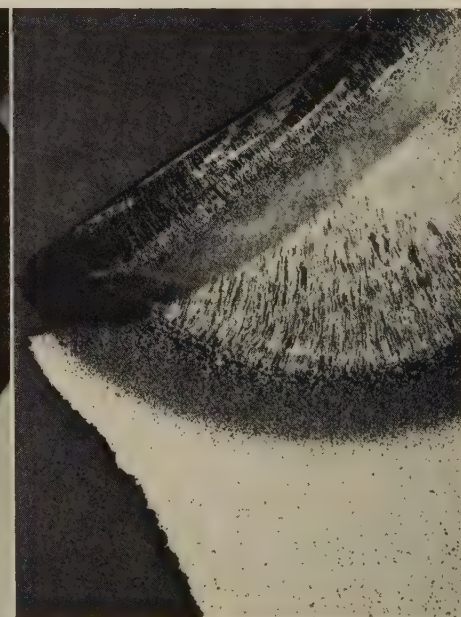
4821 A polished and etched section through the toe of the flange weld at S (crack nucleus) in 4820, taken normal to the fracture surface (at left). The toe of the weld had a maximum hardness of Rockwell C 45.

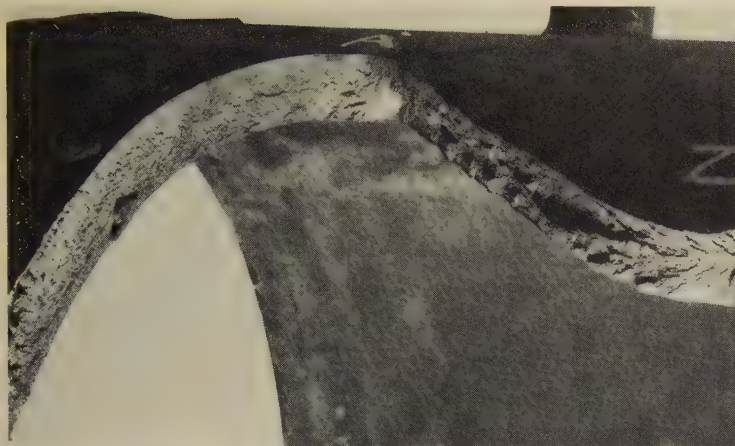
4822 View of the far left end of the top segment of the fractured pressure-vessel shell in 4818 (facing page), showing chevron marks. The chevron marks were smeared subsequent to fracture but can be clearly identified as pointing to the right.

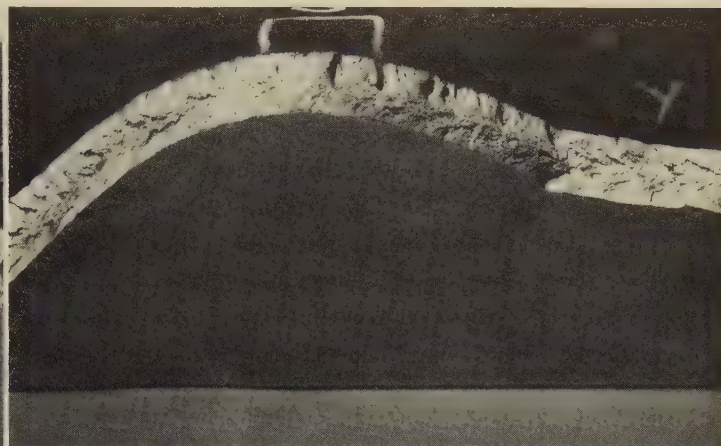
4823 View of the top segment of the fractured pressure-vessel shell in 4818, showing an area just to the right of the area in fractograph 4822 (at left). Again, chevron marks are visible and consistently point to the right.

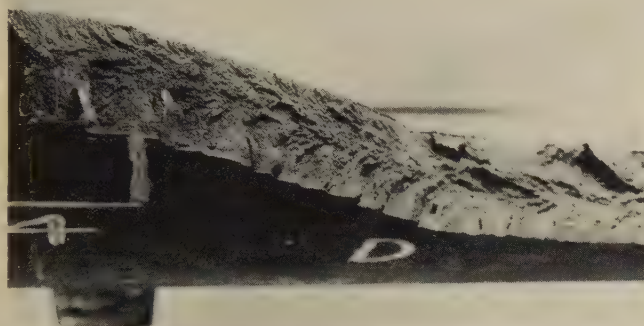
4824 View of the bottom segment of the fractured shell in 4818, showing an area opposite the one in fractograph 4823. This view also reveals sharply defined chevron marks that point to the right.

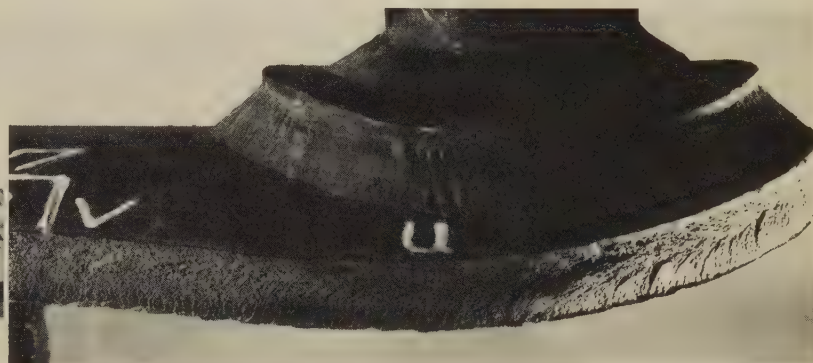
4825 View of the top segment of the fractured shell in 4818, showing an area just to the left of the fracture origin. The continuity of the chevron marks that point toward location S (at right end) is much more perceptible here than in 4820, because of a difference in illumination.

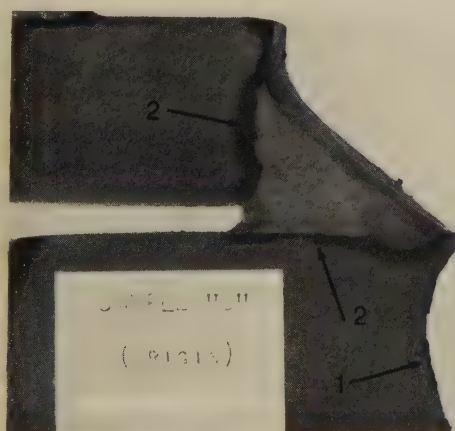
4826 Section through the flange weld in 4820 and 4825, taken at the fracture origin and normal to the fracture surface, shown in profile at bottom right (arrow 1). Heat-affected zones (arrows 2) appear as shadows here.

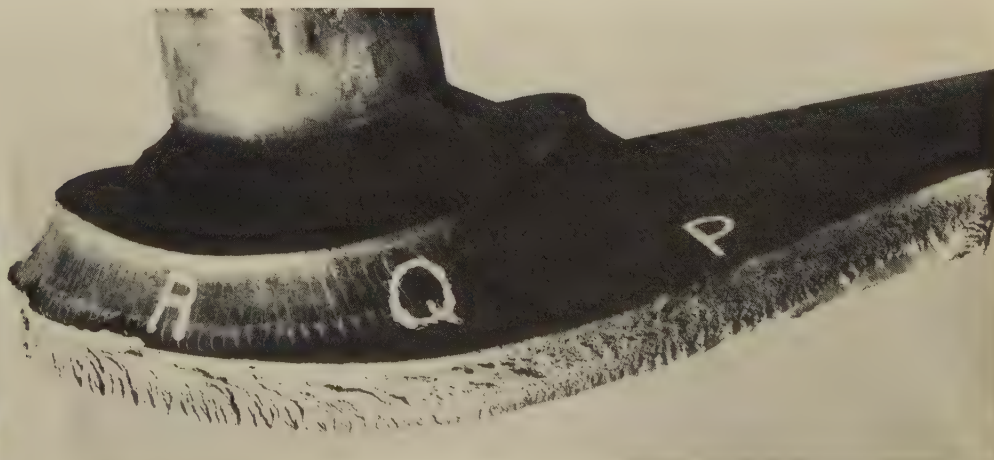
4827 View of the top segment of the fractured pressure-vessel shell in 4818, showing an area of the fracture surface just to the right of the crack nucleus. Note that here the chevron marks clearly point to the left, toward the fracture origin. The crack ends at far right, where a section was removed for testing.

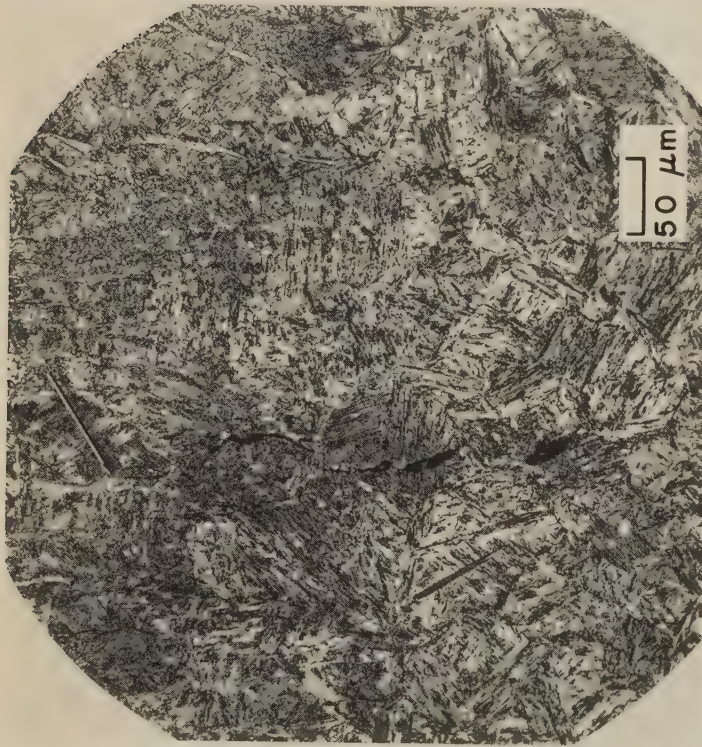
Micrograph (2% nital) 200×
4829 A polished and etched section taken through the weld in the fractured roof-truss angle in 4828, showing a crack that extends from the weld (at arrow) into the heat-affected zone. The crack apparently formed during welding and propagated at high velocity while the truss was at low temperature and under stress from the wind (the truss was not yet covered).

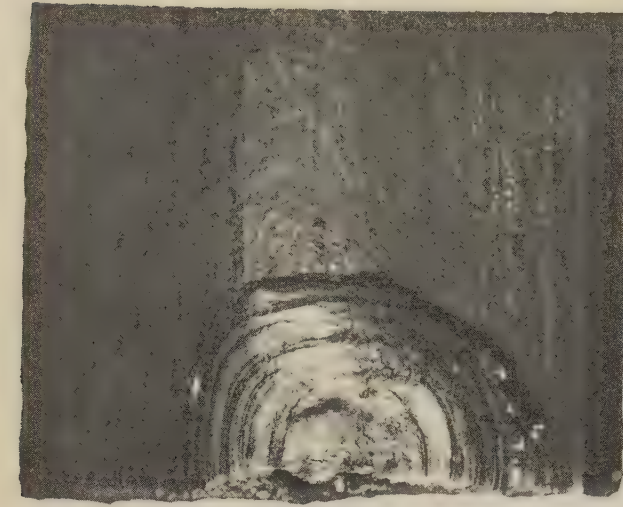
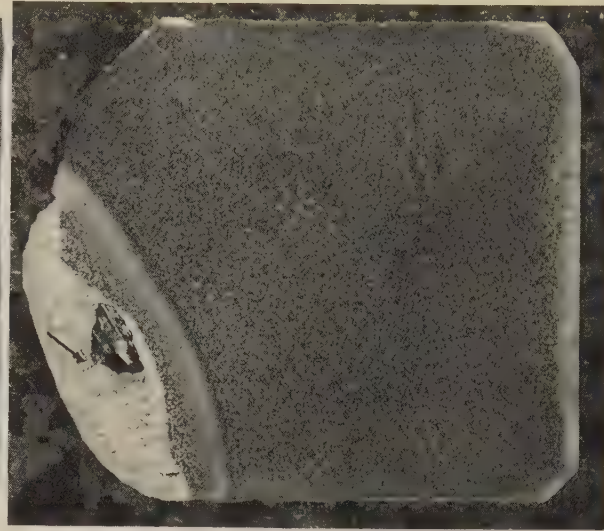
Photograph (4830); macrograph (4831) Both at 5×
4830 Above (4830) is a view of the weld at 5× magnification. Note that the fracture (in profile at left) passes through the center of the weld. Below (4831) is a portion of the fracture surface at the weld, after polishing and etching (2% nital). A crack is visible (at arrow) at the tip of the cavity. Hardness was 187 Bhn in base metal, 516 Bhn in heat-affected zone, 363-534 Bhn in weld.

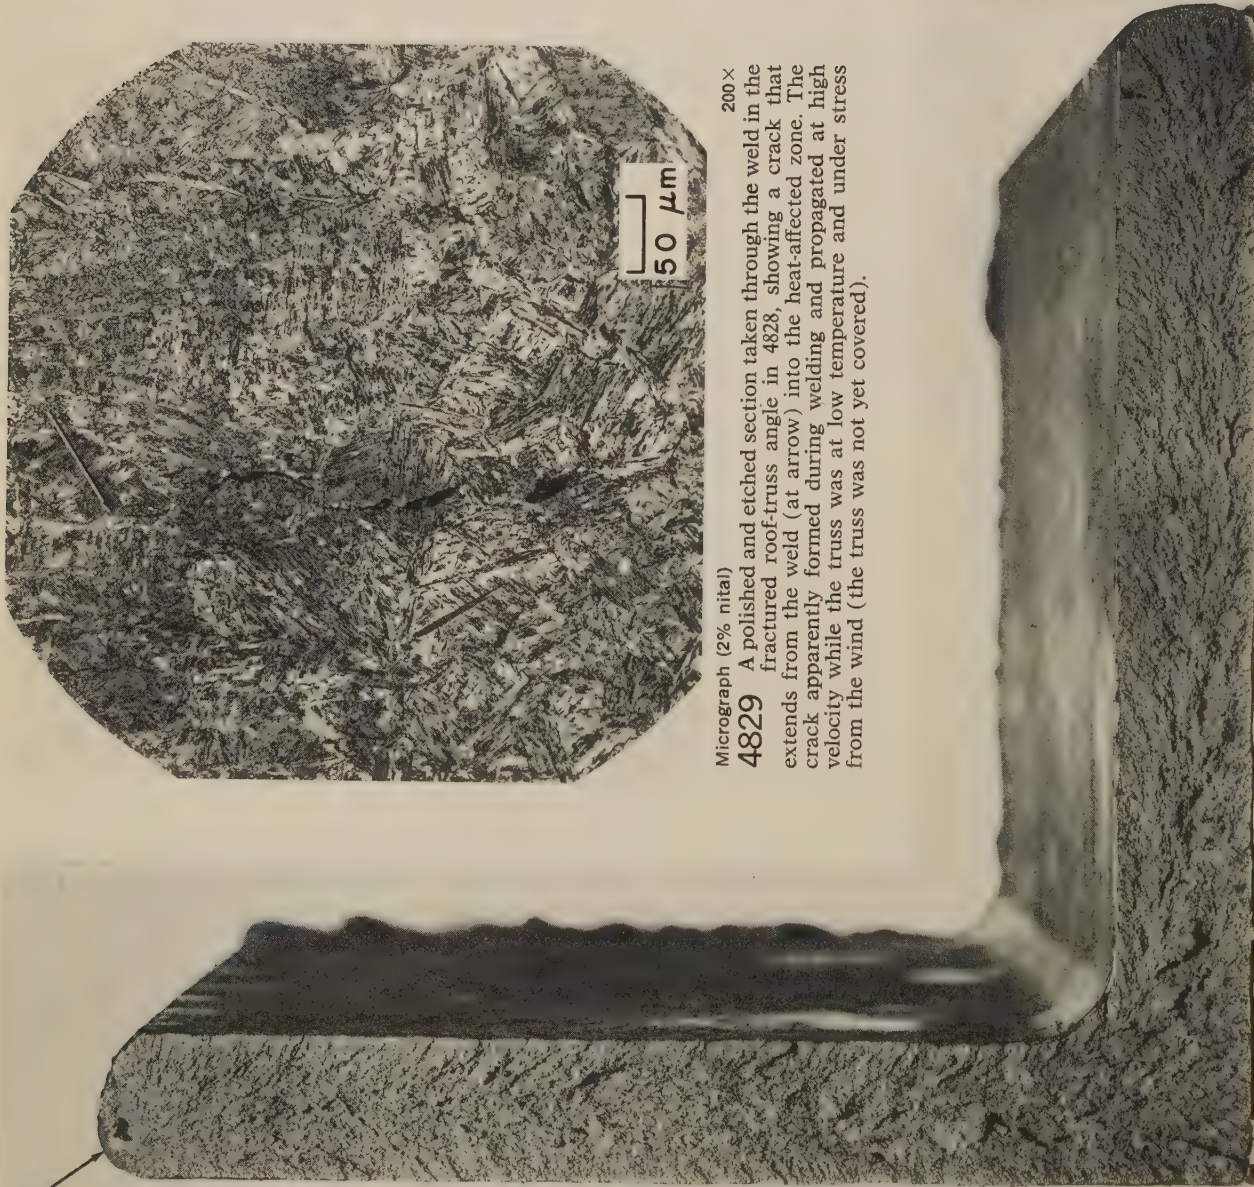
Light fractograph 1 1/2×
4828 Surface of a fracture in a 1033 steel angle 4 by 1/2 in. that formed part of a roof under construction. Fracture occurred when the temperature was below freezing and the wind velocity was 30 to 40 mph. Visible are chevron marks, which clearly point toward the fracture origin (at arrow) at a weld deposit in the upper edge of the vertical leg. Note the large cavity in the weld zone. See also 4829 to 4831.

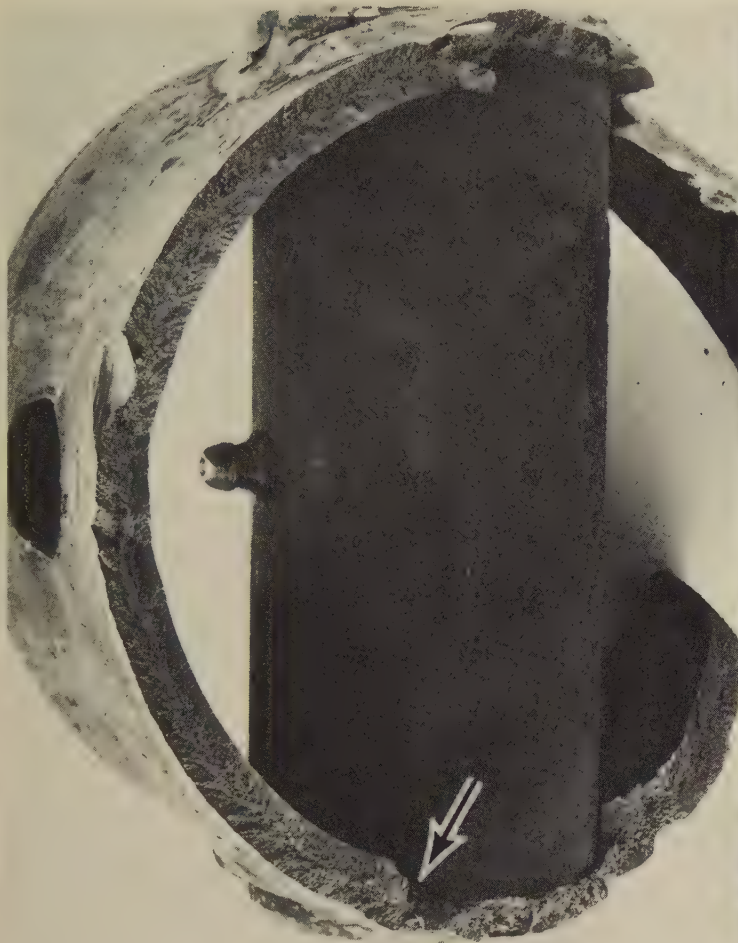
4832 Surface of a brittle fracture in an axle made of cold drawn and stress-relieved 1035 steel tubing. Fracture originated at a weld defect (at arrow) during very cold weather. Visible are chevron marks, which show that the fracture progressed clockwise along the left wall before the remainder of the axle wall (cross section shown incompletely here) ruptured in a ductile manner.

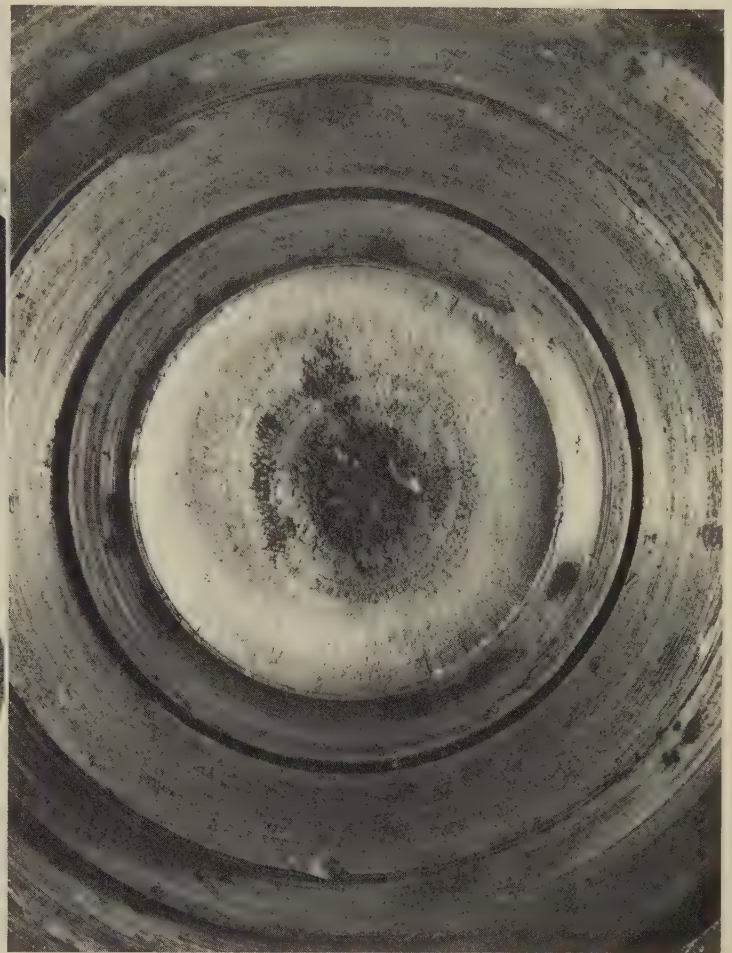
4833 Surface of a fatigue fracture in a shaft of medium-carbon steel (composition approximately that of 1035) with a hardness of 143 Bhn. The fracture occurred under rotating bending. Fatigue cracks began at several locations within a sharp tool mark in a fillet that had an adequate radius, and joined around the circumference as they penetrated to the center.

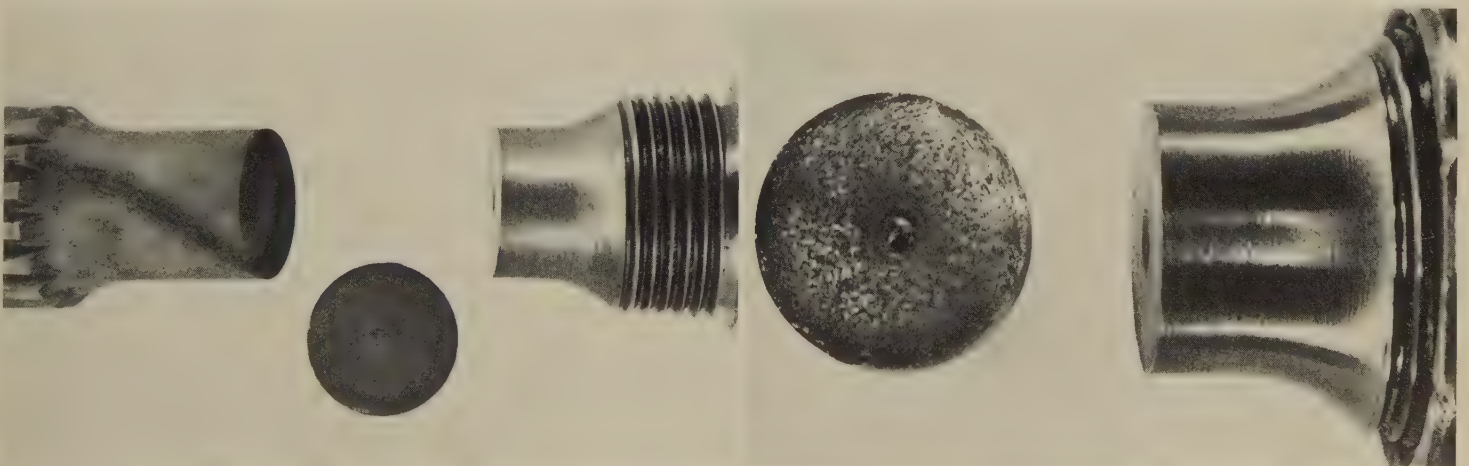
4834, 4835 At left (4834) is a view of a drive shaft of 1035 steel, with a hardness of Rockwell C 34, that fractured under torsion overload, twisting off in a fashion that produced a surface almost as flat as if it had been machined. The threaded portion, at right, contains a fracture surface. A thin slice containing the mating fracture surface was cut from the portion at left; this slice is shown at center, with the fracture surface up. Shaft portion at left, including cut fracture surface, was hot etched in equal parts of hydrochloric acid and water to reveal deformation flow and forging flash lines. The plastic deformation is characteristic of torsion overload in ductile metals and is not typical of rotating fatigue. At right (4835) is a higher-magnification view of the threaded portion of the fractured drive shaft in 4834 and the mating surface of the fracture.

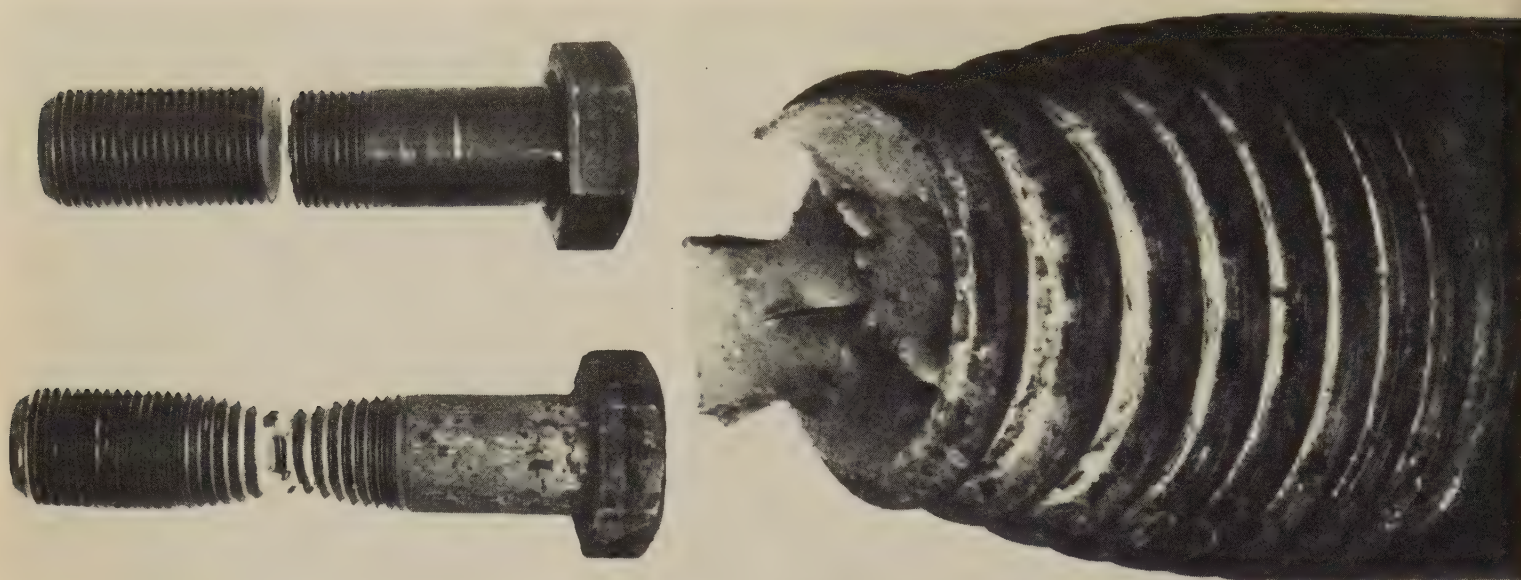
4836 Two bolts of 1038 steel that fractured in tension overload, showing the influence of hardness on fracture characteristics. Water-quenched bolt at top had a hardness of Rockwell C 57 and was brittle; annealed bolt at bottom had a hardness of Rockwell C 15 and was ductile. See 4837.

4837 Higher-magnification view of the right-hand segment of the fractured bolt at the bottom in 4836 (left). Note that appreciable reduction in cross-sectional area occurred in this bolt before final rupture took place, which yielded a ductile-fracture surface of the cup-and-cone type.

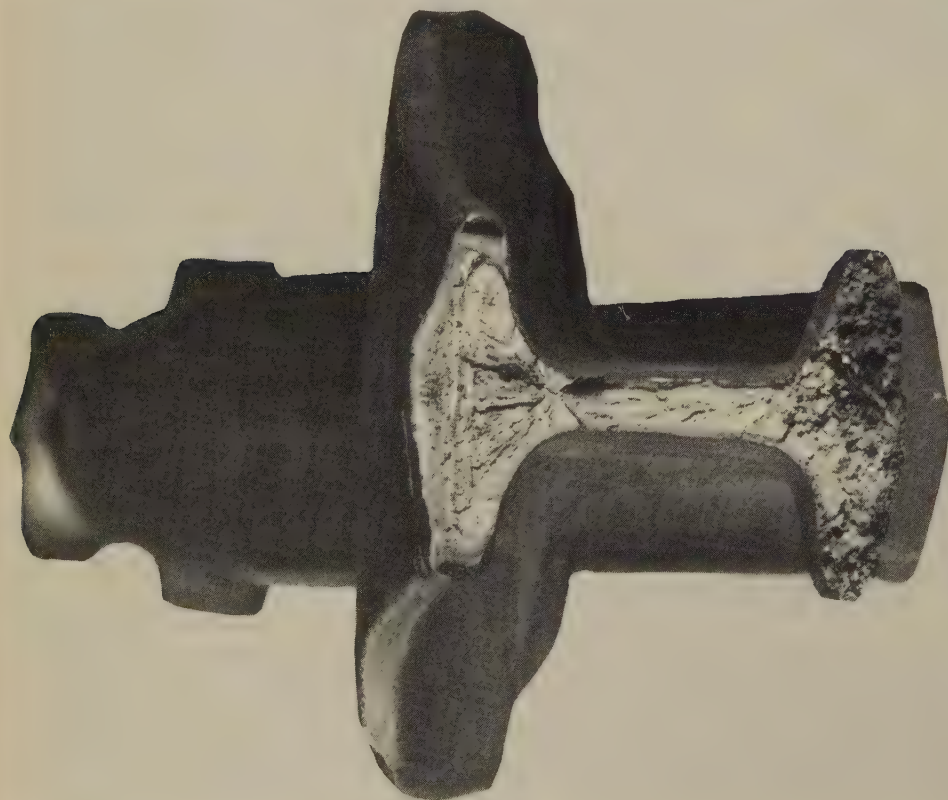
4838 Forged axle of 1040 steel that fractured while being hot stretched prior to quenching. The axle had been severely overheated during the heat treatment, which produced a weak, coarse-grained microstructure with damage at grain boundaries caused by "burning" (incipient melting). "Burning" darkened the areas at right end of the fracture surface.

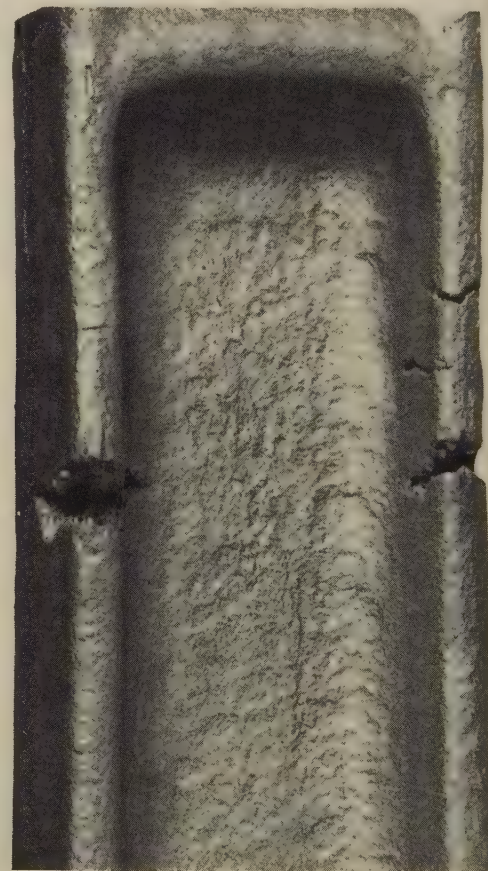
4839 A forged I-shaped axle section of 1040 steel that experienced tear fractures during a hot straightening operation. This axle, like the one in 4838, had been embrittled by "burning" during severe overheating.
